Mason County Flood May 24 – 25, 2010

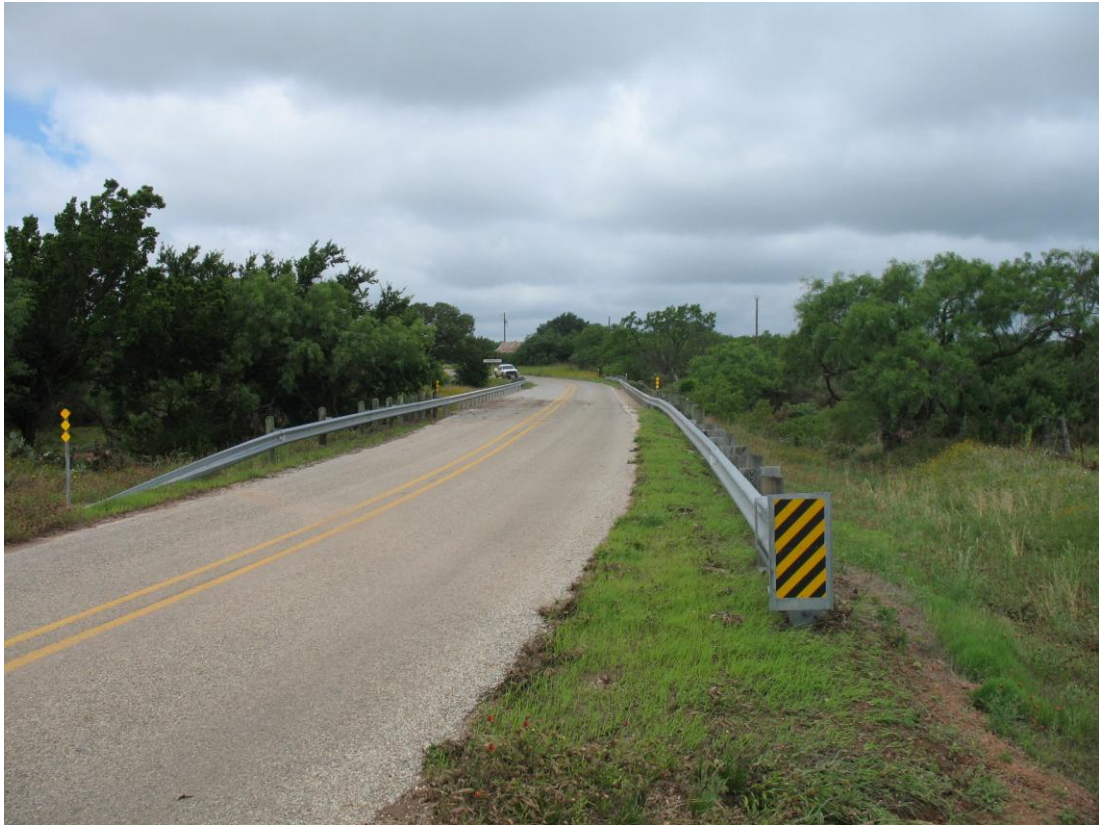
Figure 12. FM 1222 that was overtopped by floodwaters on May 24, 2010.

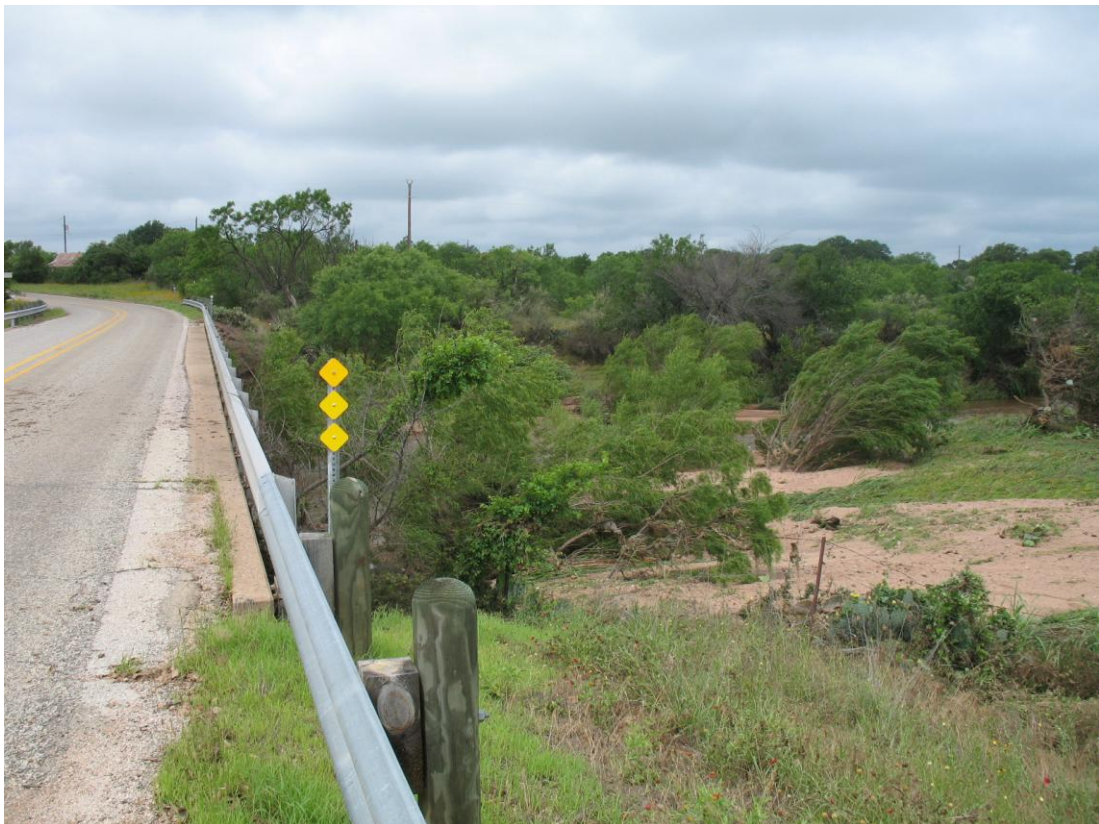
Figure 13. Downstream side of FM 1222, near Katemcy.

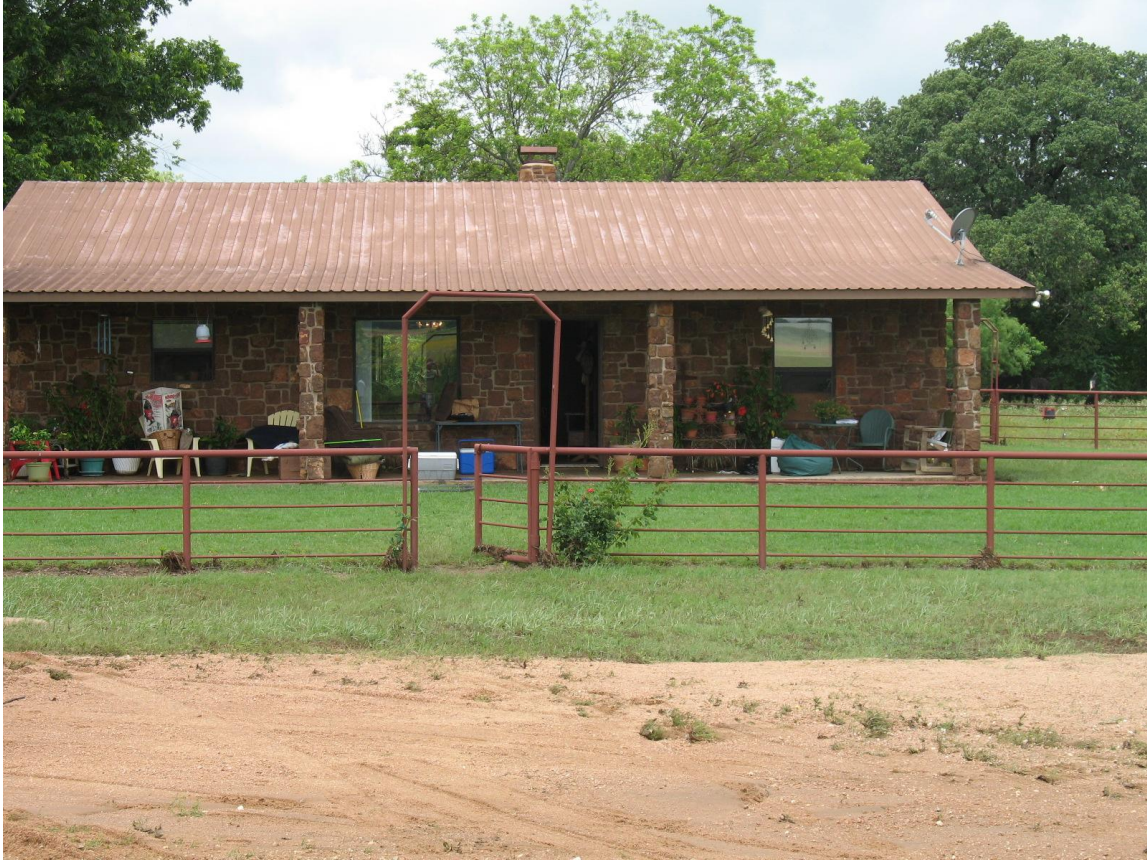
Figure 14. Home near Katemcy that received a couple of inches of water from flooding.
